# Manhole Inspection Summary

Manhole # S4100\_024MH

**Location** Address: **1241 DARLEY AVE**

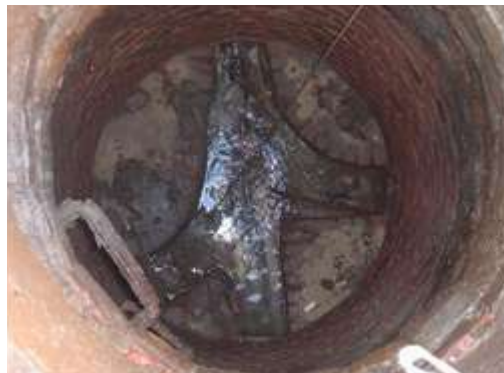
Top View

Corroded steps. Evidence of surcharge - Bench debris. Channel debris.

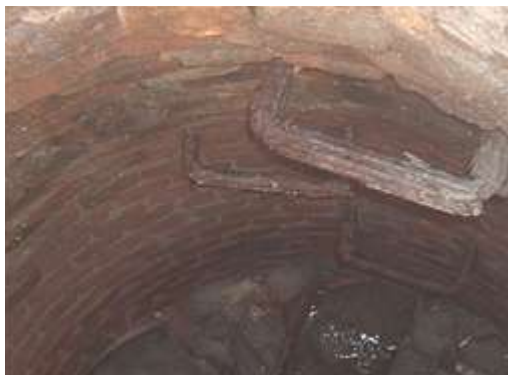
Defect

Barrel infiltration.

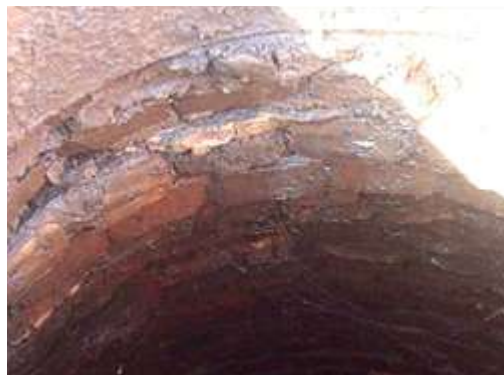
Defect

Frame leaks. Adjustment deterioration and infiltration.

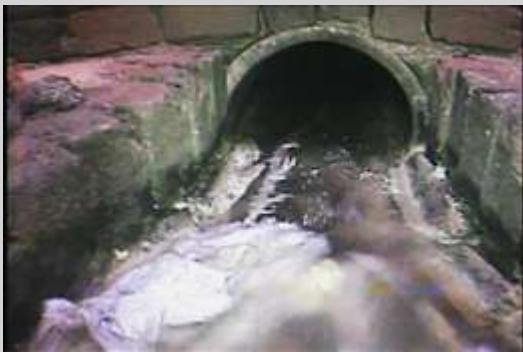
### 8 in. Circular Gravity Sewer Pipe Out @ 12 O'Clock

Channel deterioration.

Deposits: ☐ None ☒ **Mud** ☐ Sludge ☒ **Debris** ☒ **Grease**

Silt Depth: **2** (in.) Deposits Extent: **Light**

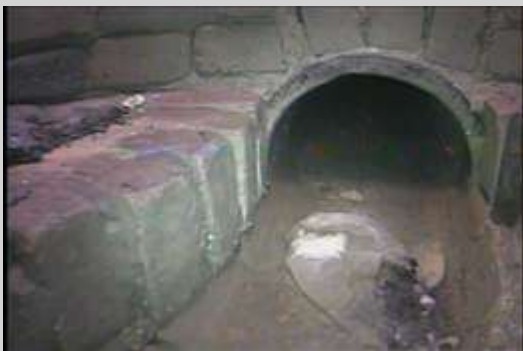
### 8 in. Circular Gravity Sewer Pipe In @ 3 O'Clock

Deposits: ☐ None ☒ **Mud** ☐ Sludge ☒ **Debris** ☐ Grease

Silt Depth: **2** (in.) Deposits Extent: **Light**

Infiltration: **Evidence** Pipe Seal Cond: **Unknown**

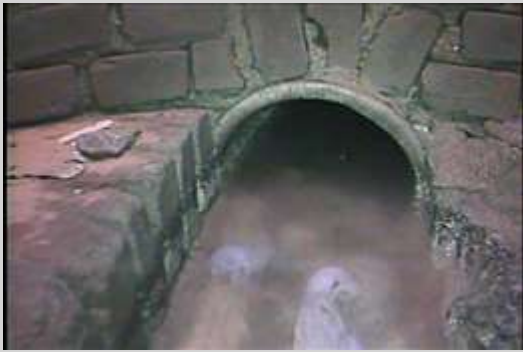
Pipe In @ 6 O'Clock

Deposits: ☐ None ☒ **Mud** ☐ Sludge ☒ **Debris** ☐ Grease

Silt Depth: **1** (in.) Deposits Extent: **Light**

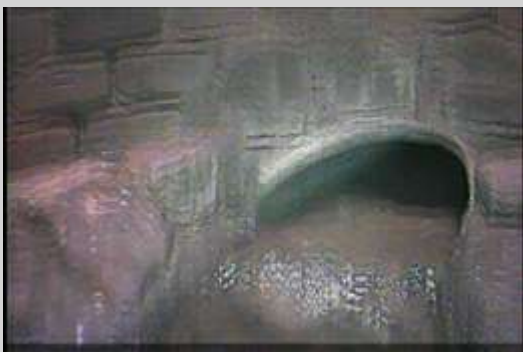
Pipe In @ 7 O'Clock

Deposits: ☐ None ☒ **Mud** ☐ Sludge ☒ **Debris** ☐ Grease

Silt Depth: **2** (in.) Deposits Extent: **Light**
